Robbed by Kern County Sheriff's Deputies Testimony by Alexandra Wilson

§ 2 – We Documented the Conditions of 2232 Commercial Ave. on 8–31–2015

August 31, 2015 – **Dilapidation** of the property was apparent: Kevin and I exercised **rights of entry** for the purpose of taking **possession** and gaining **occupancy** of the property. We walked through the open gate, then filmed and uploaded the following two videos in order to be able to prove the condition we found it in:

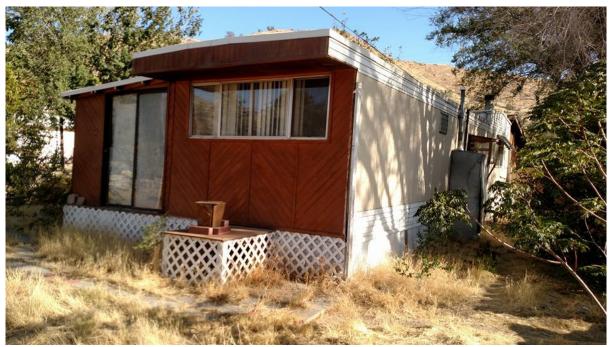
Dried grasses imposed a fire hazard to the property and neighborhood.

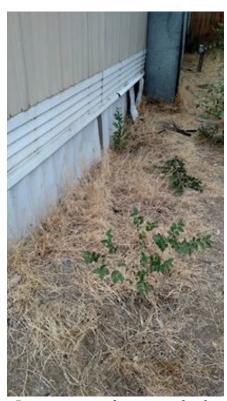
Root systems of invasive shrubs on west side of house grew toward waterlines beneath the house – see pages 50 and 51.

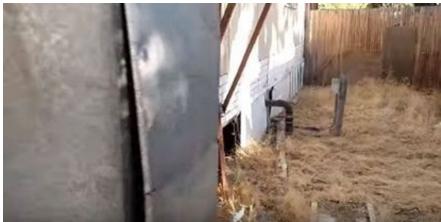
Debris and dried grasses on west side of house.

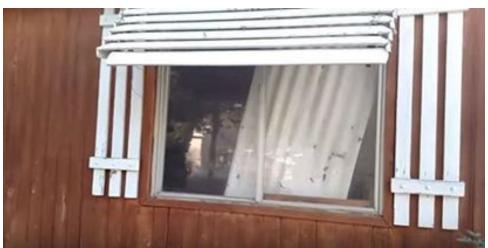
First window on the right – metal panel leaning against glass.

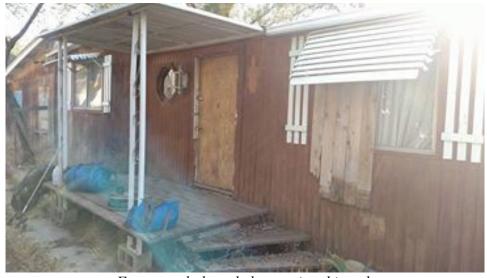
Front porch, boarded up, paint chipped.

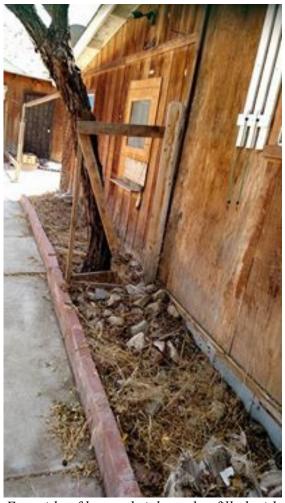
East side of house, brick garden filled with rocks and trash. Wooden contraption nailed to the walnut tree.

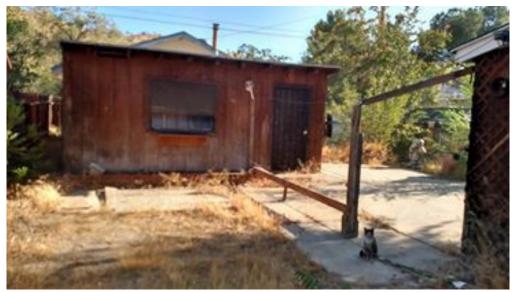
A wooden contraption connected both buildings, serving no apparent purpose.

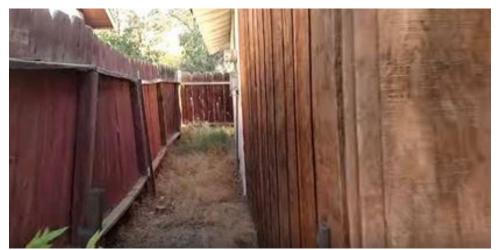
Behind rear building at south side of property, facing west. Dry grasses threaten wood building and fence.

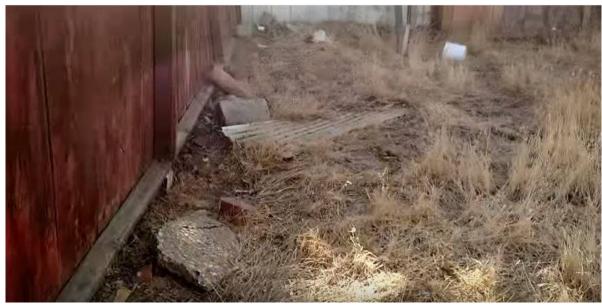
Looking into backyard, covered in rocks, garbage, and dried grasses.

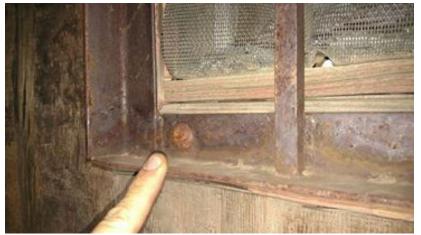
Closeup of barred window on left from above photo – glass window shattered.

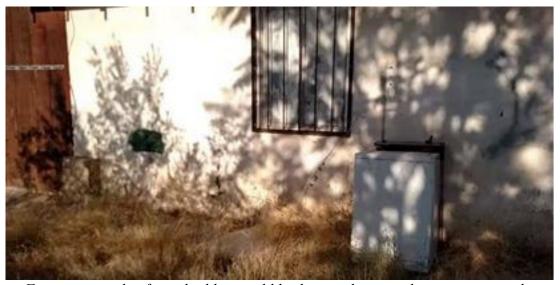
Facing west side of rear building – old broken washing machine sitting outside.

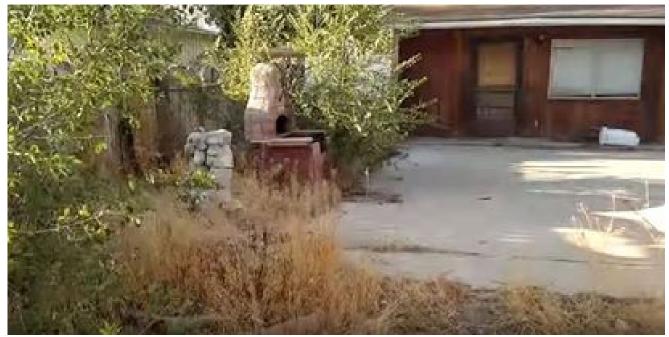
Facing north toward back side of main house. Brick circular firepit buried in grasses in lower left foreground. Dried grasses imposing fire hazard to neighborhood.

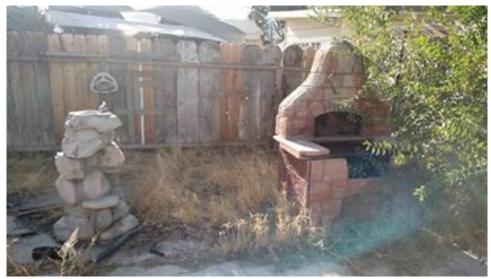
Dried grasses imposed a fire hazard to the neighbor's property and fence.

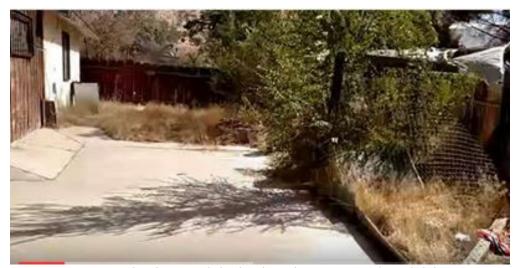
Turning back toward the backyard – overgrowth and debris.

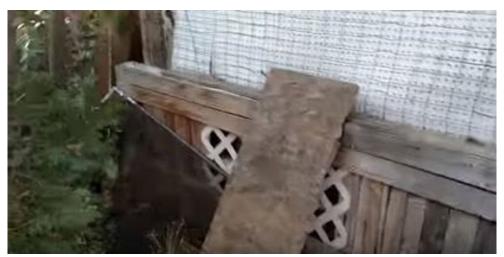
Looking slightly westward from previous photo – a wooden contraption attached to house is surrounded by debris.

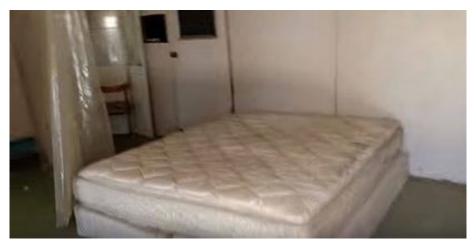
Turning to left (as discovered); plastic hanging from ceiling.

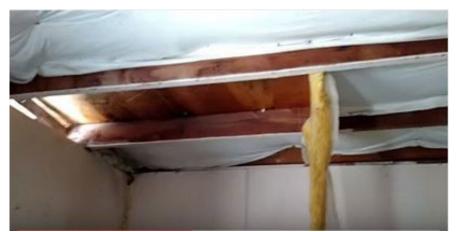
Insulation hanging from ceiling, hole in wall.

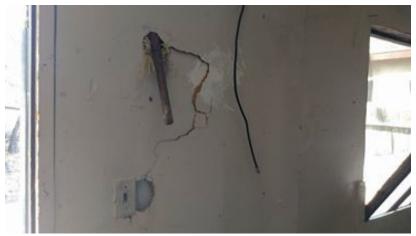
On left side of the top photo on previous page – wooden handle bashed into the wall as discovered.

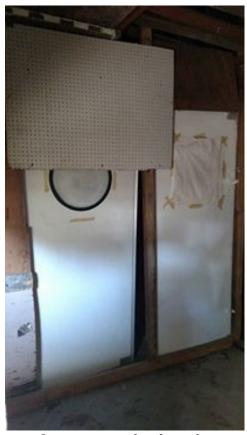
On opposite side of wooden pegboard, facing the non-functioning meat locker doors. A second pegboard covers part of the doors.

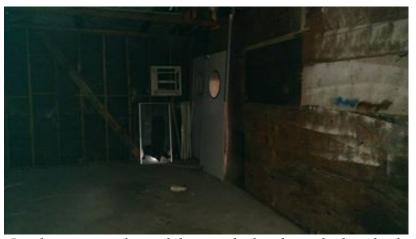
In adjacent room beyond the meat locker doors, looking back toward them. Broken glass scattered across the floor.

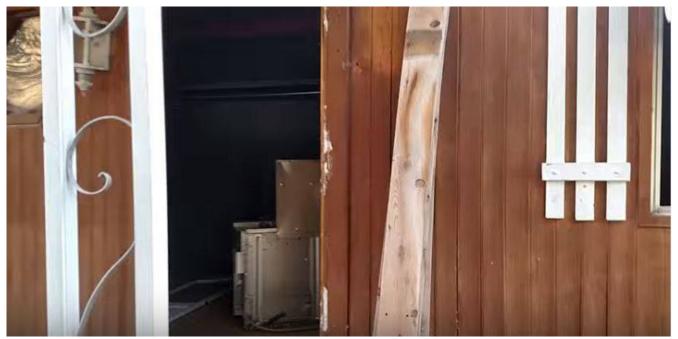
A defunct washer sits in the entryway.

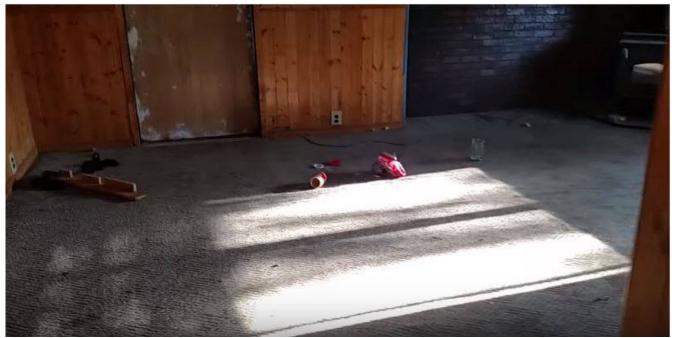
Facing opposite direction as previous photo, looking into the living room; old food on the floor, thick dust covering the room.

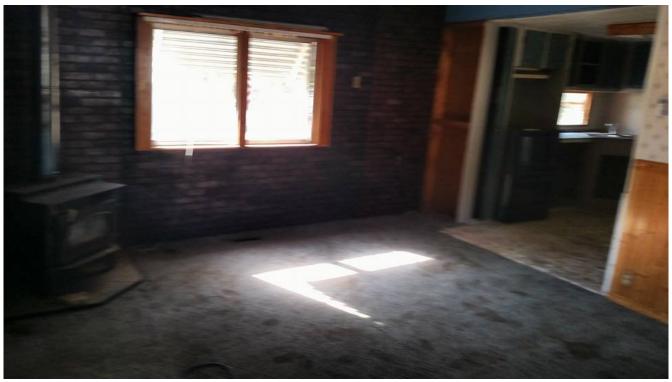
Standing in the living room facing the kitchen. Entryway to house is to the right and not shown in photo. Badly stained carpet.

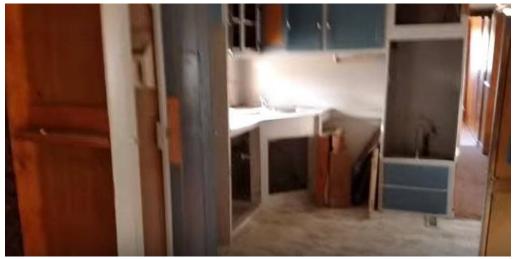
Stepping forward from previous photo, into the kitchen. Appliances missing.

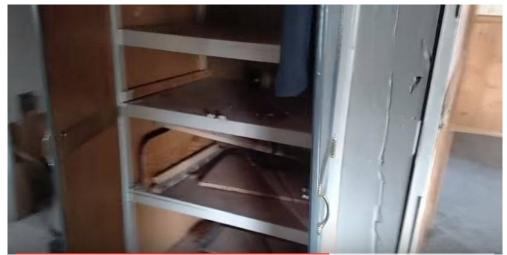
Turning to the right (east) from previous photo. Cupboards covered in dust.

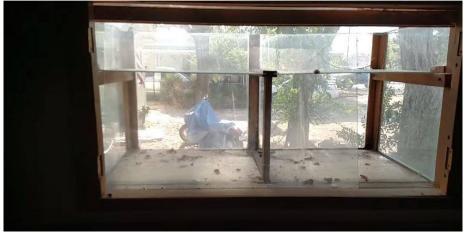
Facing westward in the kitchen. Dust-covered windowsill shows example of how dusty the entire house was.

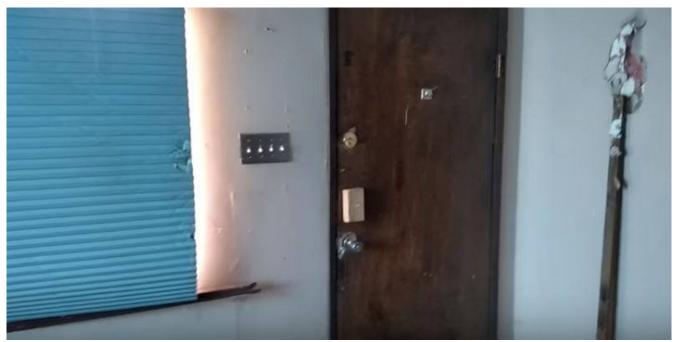
A 2" x 4" piece of lumber was bashed into the west wall.

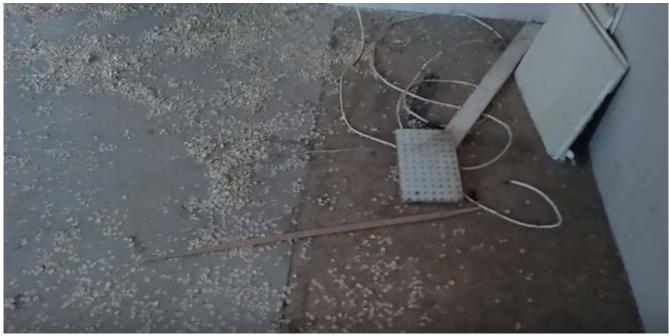
Floor covered with insulation and debris.

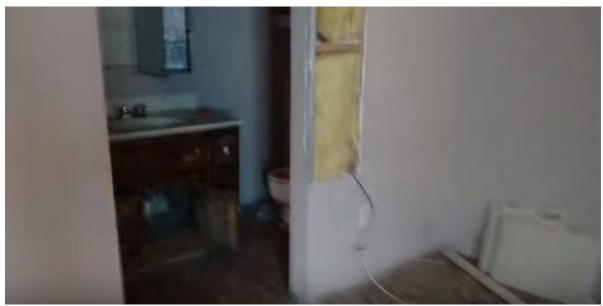
Facing northwest in master bedroom. A chunk of wall is missing, and a cord is pulled out from it is strewn across into the room.
