**Robbed by Kern County Sheriff's Deputies
Testimony by Alexandra Wilson**

**§ 7 – We discovered another
dilapidated property:
2233 Angler Ave.**

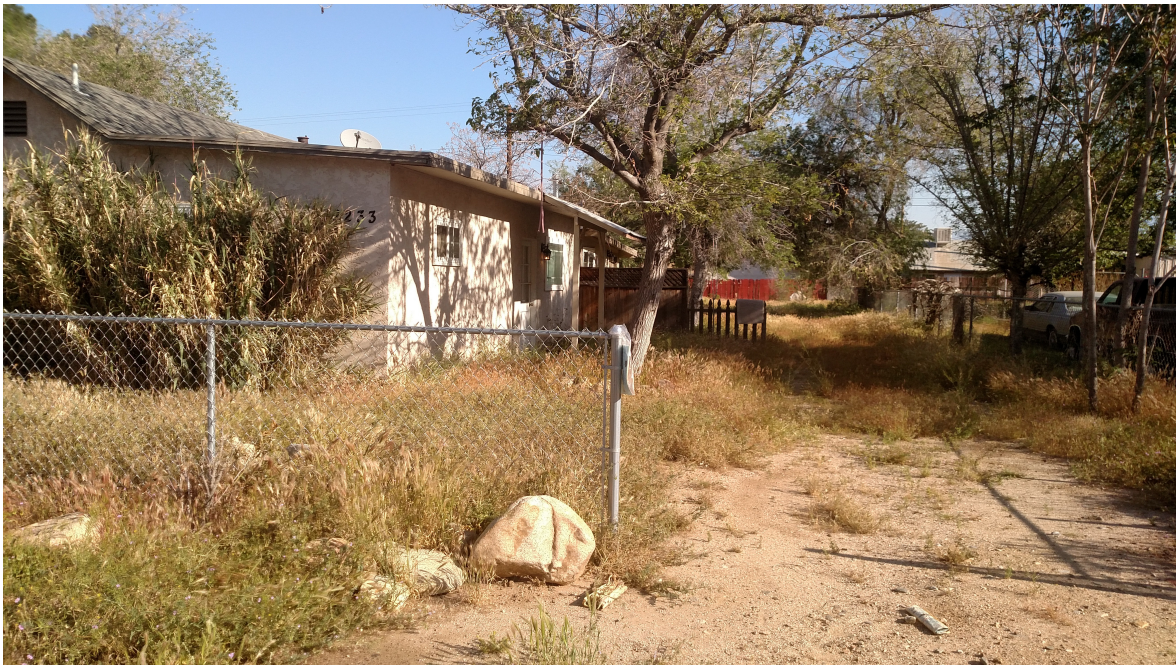
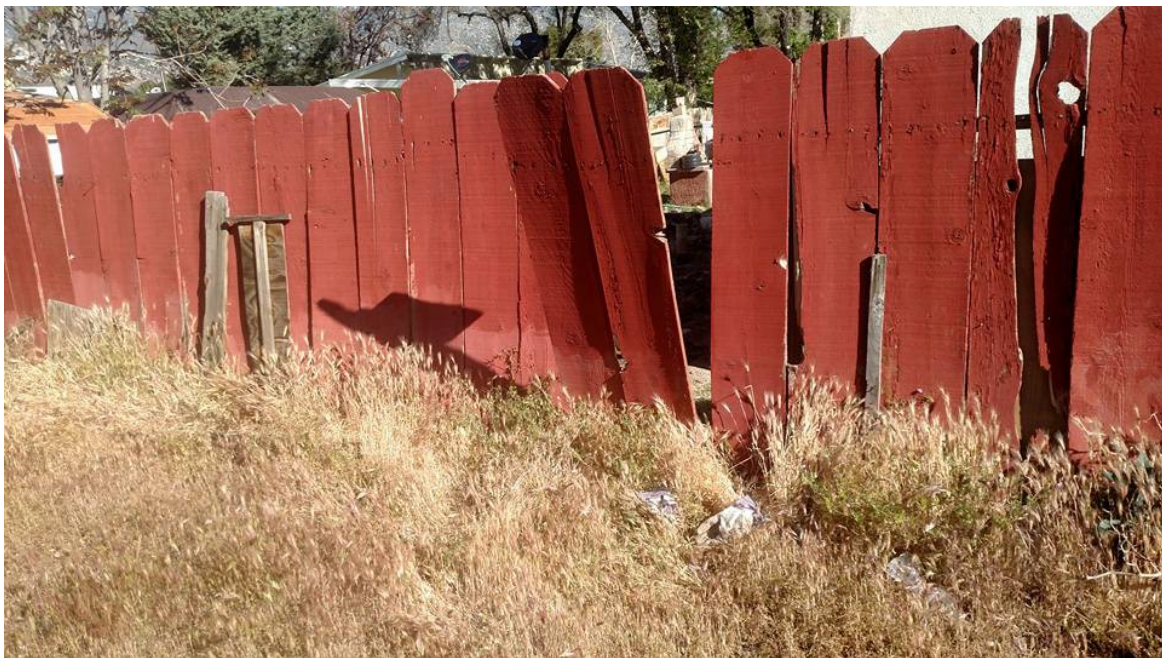
There was no gate on the front fence (*top photo*), and in late spring *tall, dried grasses* endangered the wooden structures on the property *and* the wooden fence in our backyard (*shown in background of top photo, closeup in bottom photo*). Outdated newspapers hung from the fence and littered the entryway.

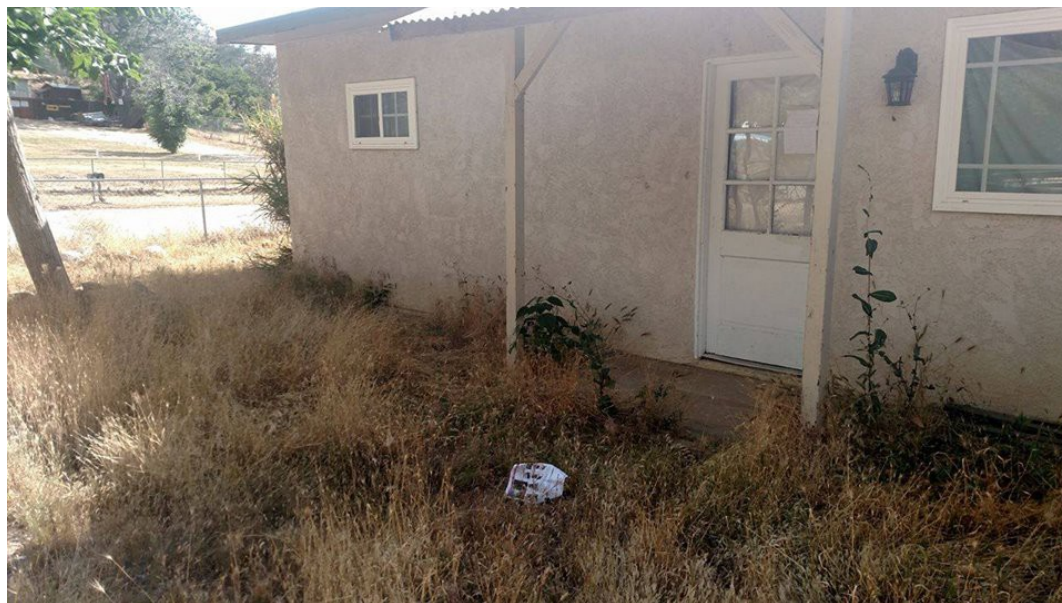
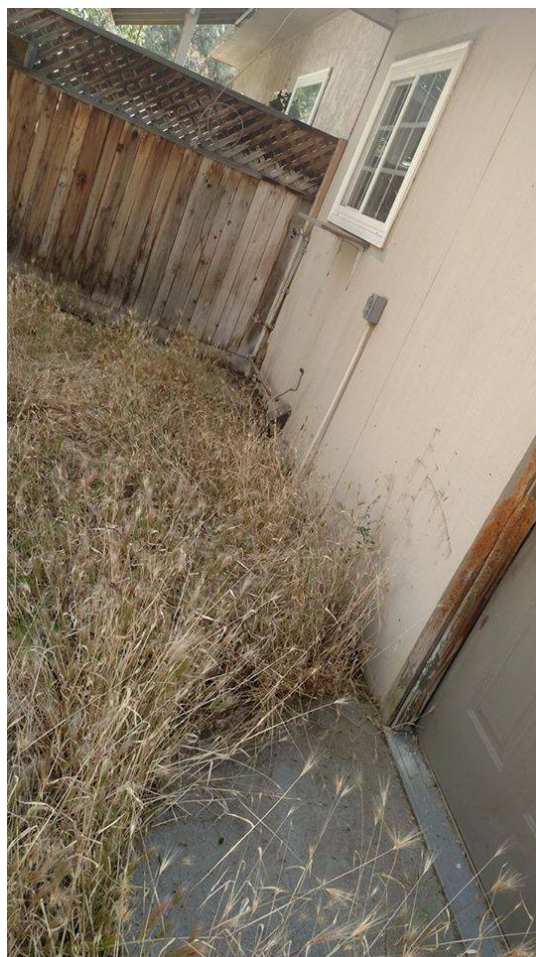
Grasses leading to the front door (*top photo*) and side door (*bottom photo*) were undisturbed, and doors and windows were covered. It was apparent *no one had entered the property in 2016.*

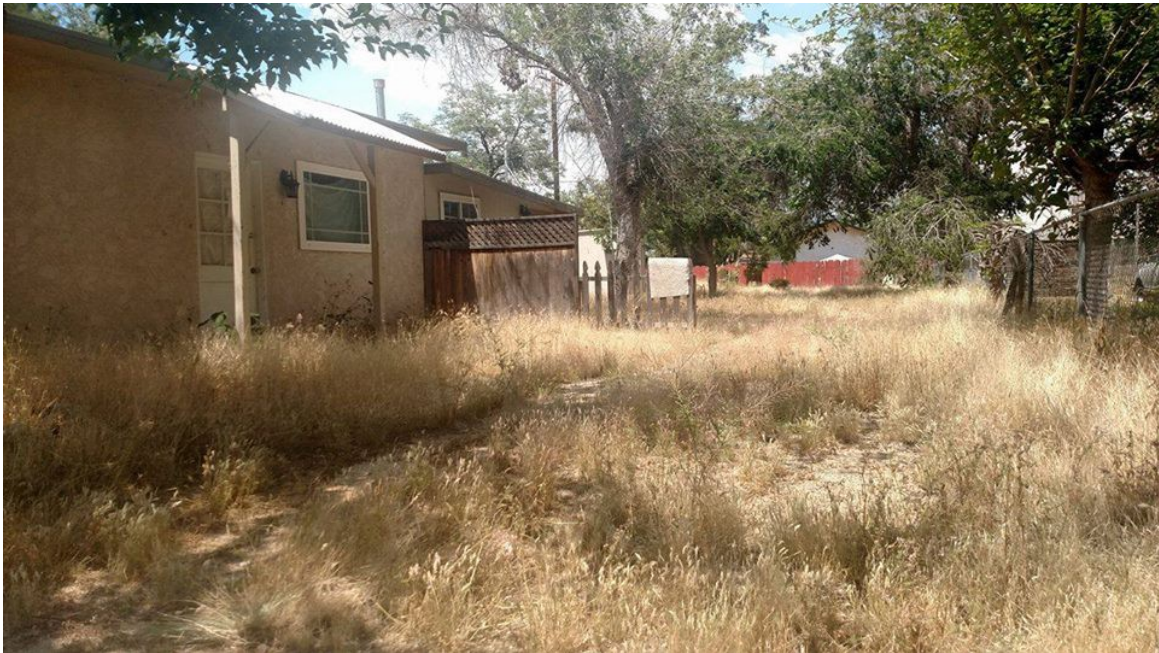
Unkempt grasses endangered the property *and* the neighborhood:

Top photo: The view after entering through the front gateway (*shown on page 114*). The side door (*shown on previous page*) is to the left (*not visible from photo*). Our property is straight ahead on the other side of the red fence.

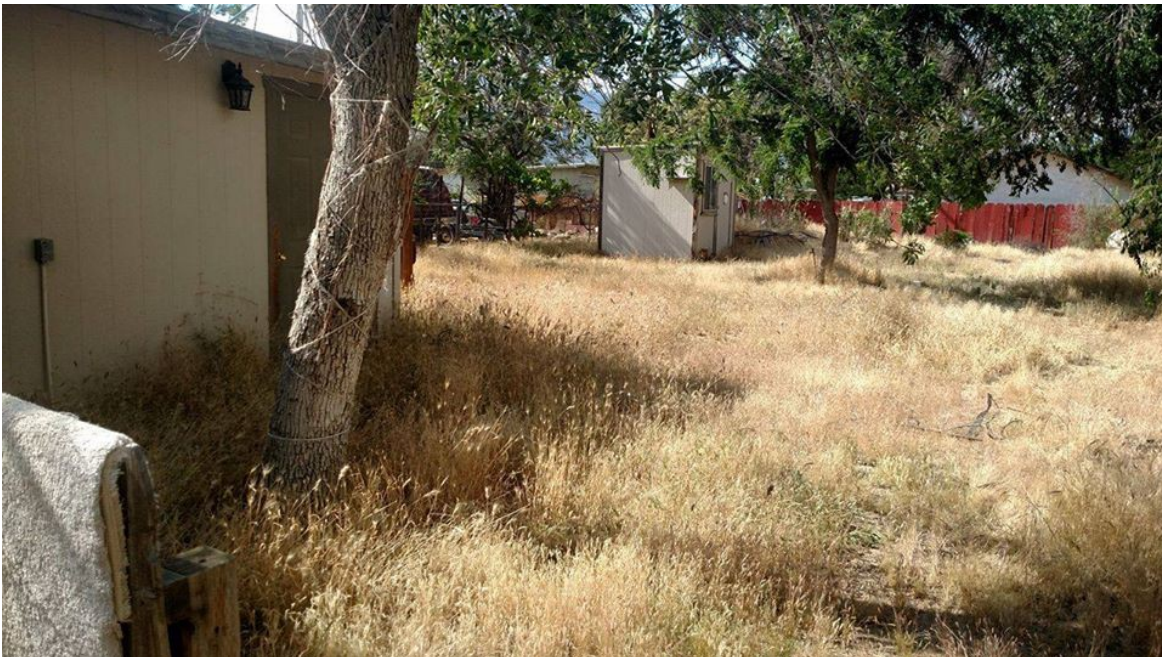
Bottom photo: Stepping forward from previous photo, looking into the backyard.

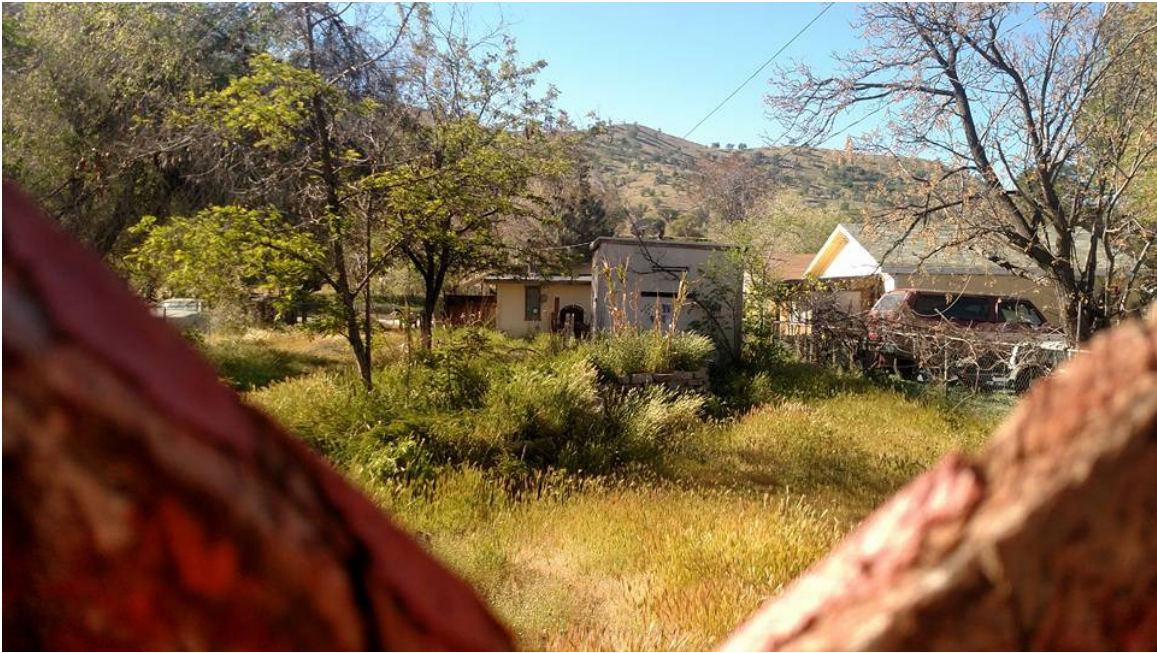
Top photo: Looking over our back fence on 4-1-2016.

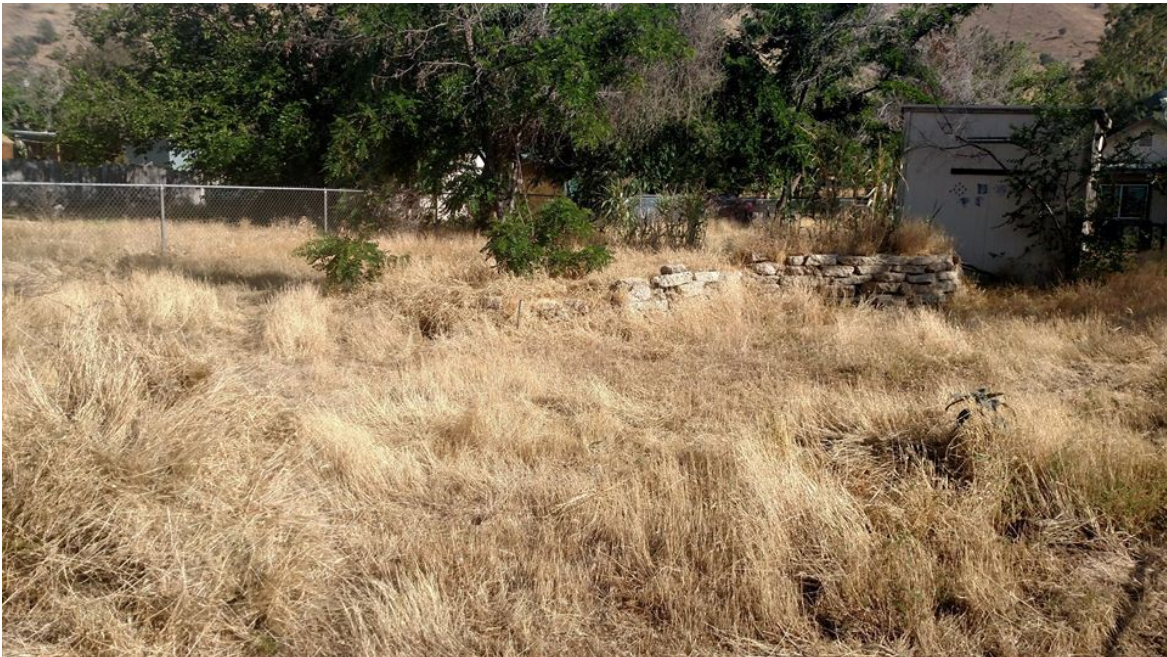
Bottom photo: Facing into the backyard from the south side of our fence. A once beautiful rock garden plateau stands overgrown; a wooden shed between the plateau and the house.

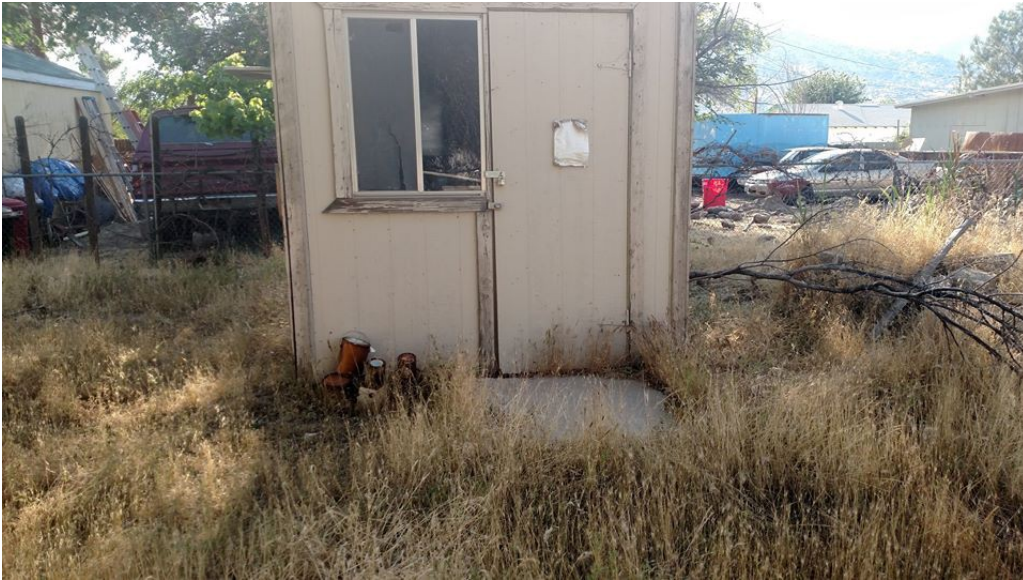
Foxtail grasses caused a fire hazard to several wooden structures, including:

1. the main house,
2. two wooden fences,
3. the shed (*top photo*),
4. three neighboring properties (and properties adjacent to those).

Top photo: Rusted cans of paint lain outside the wooden shed.

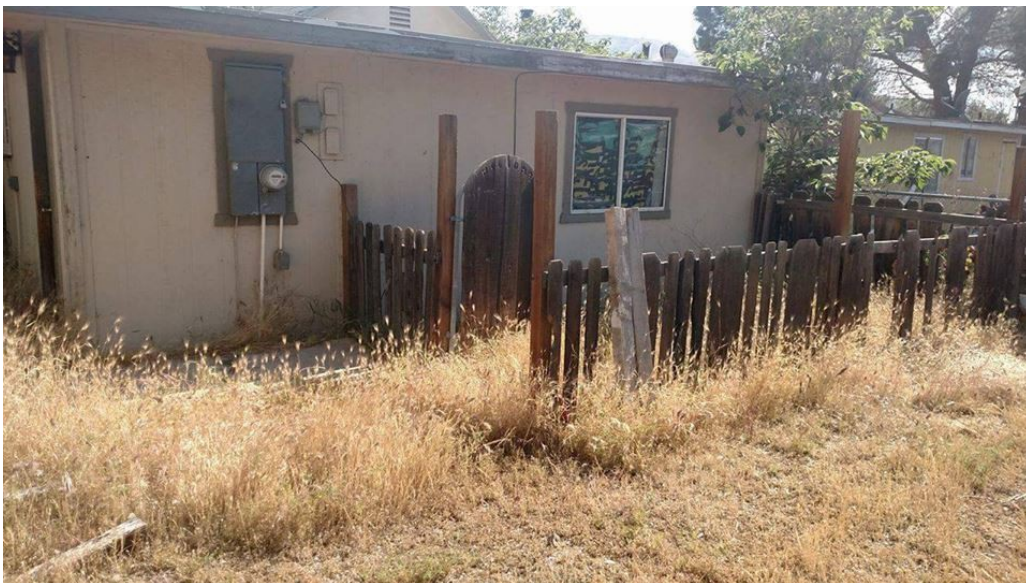
Bottom photo: Facing southwest toward the back of the house.

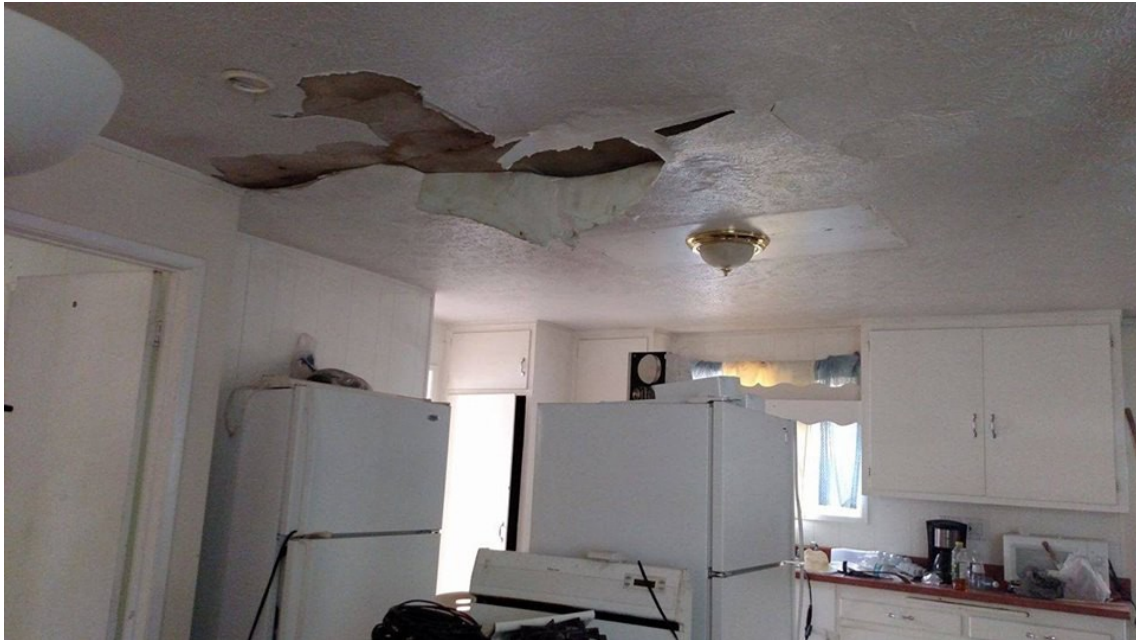
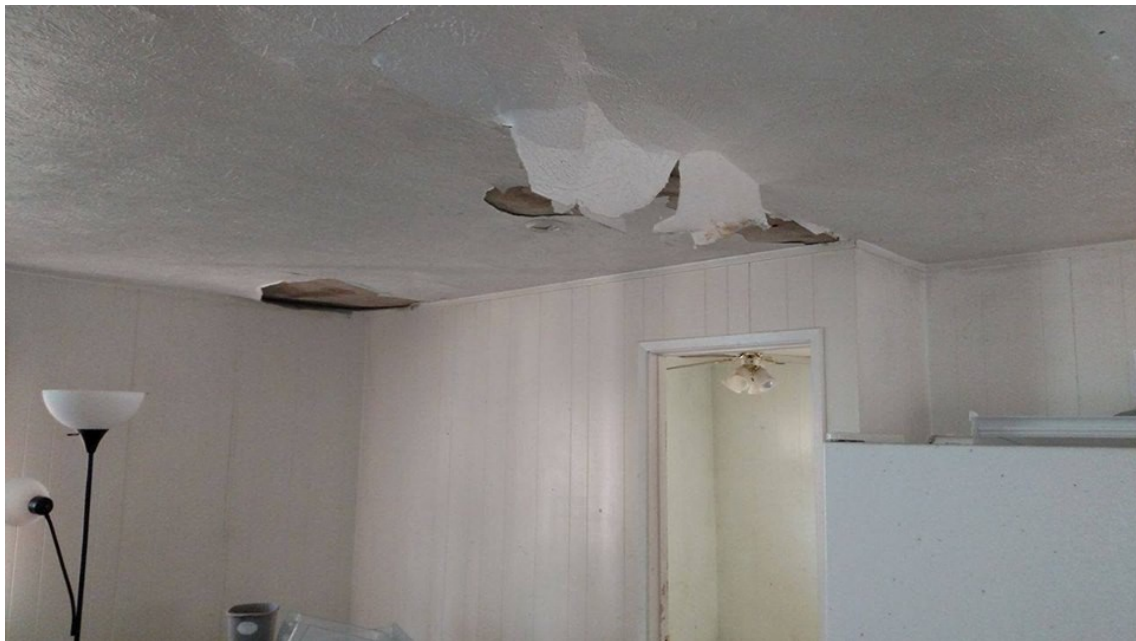
Entering through the front door, the ceiling paint was peeling where water had leaked through the roof. Paint chips littered the floor. These photos show what is looked like after I began peeling it and threw several large chunks into a trash bag.

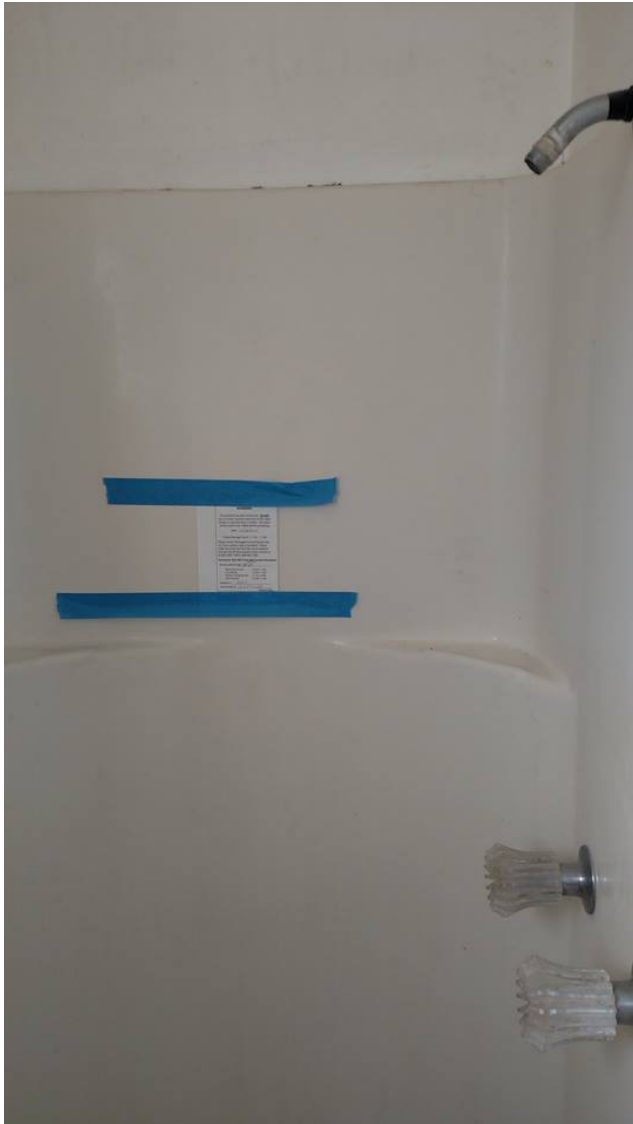
A note indicated the property had been **vacated** more than 2 years:

The note was taped to the back of the shower.
